**Flood Control Project Maintenance
Levee Inspections**

Fall 2008 Levee Maintenance Deficiency Summary Report

Levee Inspection Report By Mile - Fall 2008

City of Sacramento

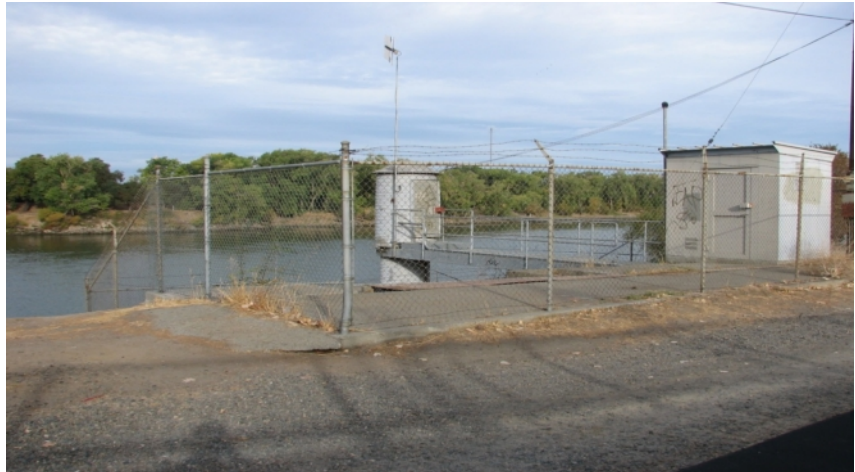
Levee Mile Report Line	1
Start Levee Mile	0.14
End Levee Mile	0.14
Location	
Category	Earthen Levee
Item	Encroachments
Recorder can (DWR)

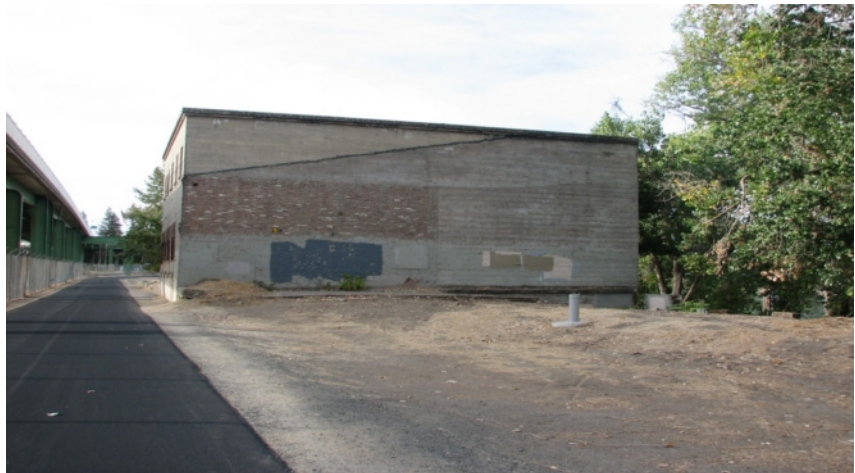
Levee Mile Report Line	2
Start Levee Mile	0.16
End Levee Mile	0.16
Location	
Category	Earthen Levee
Item	Encroachments
Historical Building : State Parks & Recreations

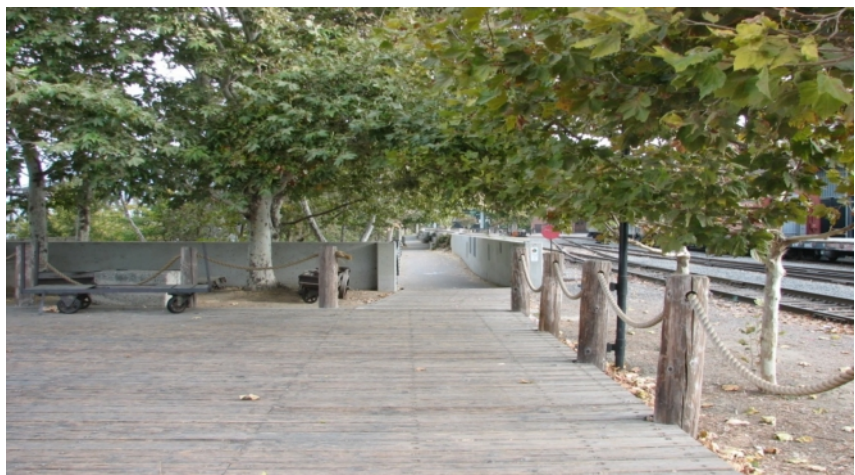
Levee Mile Report Line	3
Start Levee Mile	0.31
End Levee Mile	1.15
Location	
Category	Concrete Floodwalls
Item	Concrete Surfaces
Old Sacramento Flood wall

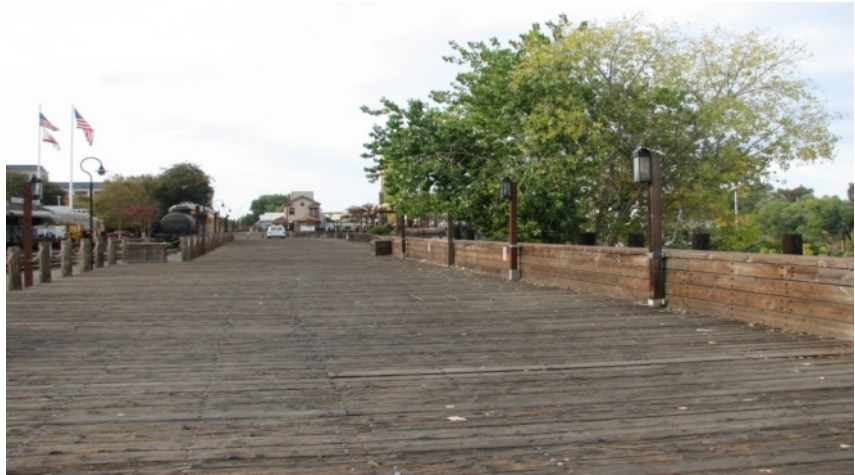
Levee Mile Report Line	3
Start Levee Mile	0.31
End Levee Mile	1.15
Location	
Category	Concrete Floodwalls
Item	Concrete Surfaces
Old Sacramento boardwalk flood wall below

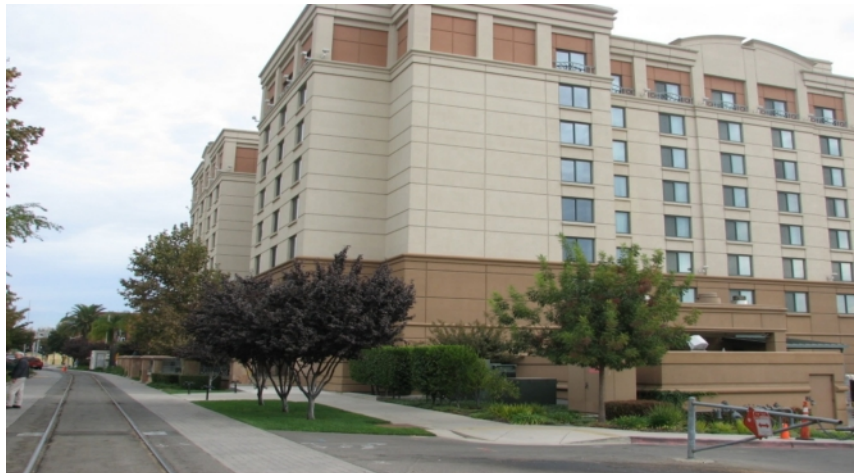
Levee Mile Report Line	4
Start Levee Mile	0.78
End Levee Mile	0.78
Location	
Category	Earthen Levee
Item	Encroachments
Embassy Suites

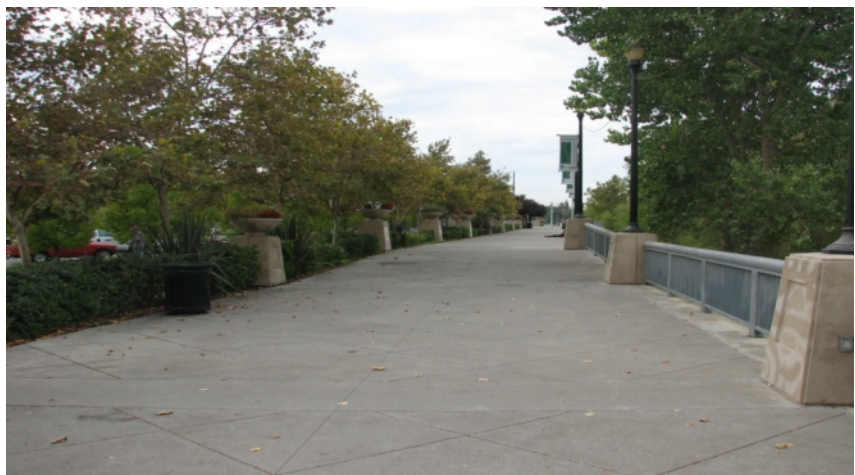
Levee Mile Report Line	5
Start Levee Mile	0.78
End Levee Mile	0.93
Location	
Category	Earthen Levee
Item	Encroachments
River walk crown with landscaping

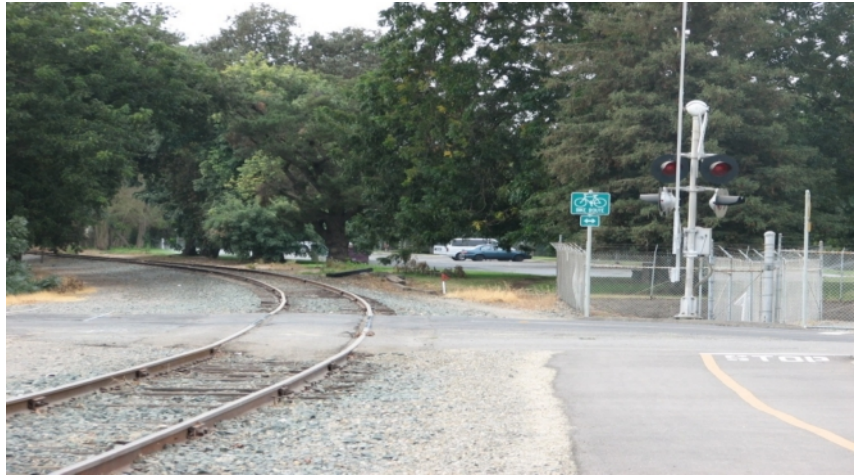
Levee Mile Report Line	6
Start Levee Mile	1.73
End Levee Mile	1.96
Location	
Category	Earthen Levee
Item	Encroachments
Miller Park at Broadway rail road track and parking area on levee

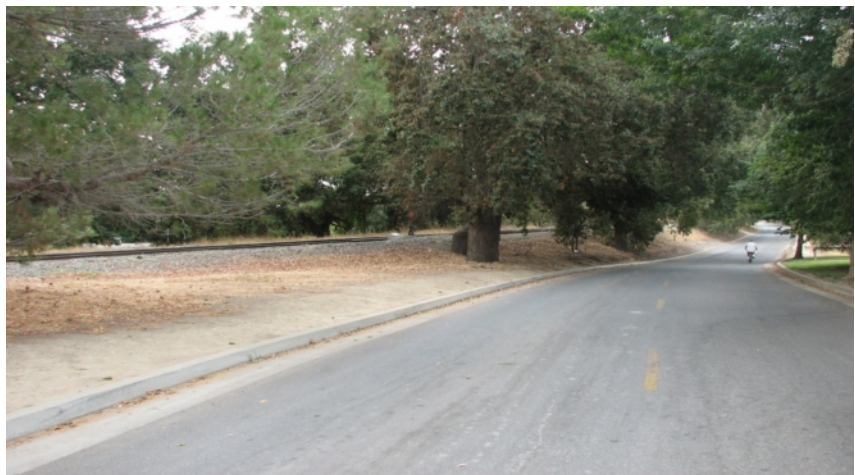
Levee Mile Report Line	7
Start Levee Mile	1.96
End Levee Mile	2.34
Location	
Category	Earthen Levee
Item	Encroachments
Rail road tracks on levee crown street to boat ramp

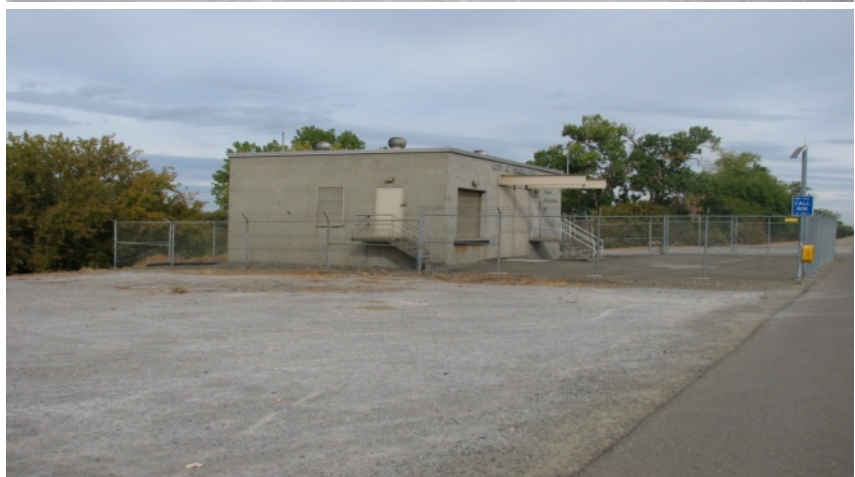
Levee Mile Report Line	9
Start Levee Mile	2.90
End Levee Mile	2.90
Location	
Category	Earthen Levee
Item	Encroachments
pump station city of Sacramento crown of levee waterside
